WILD TROUT TRUST

Advisory Visit

River Derwent, Cromford, Derbyshire

April, 2023

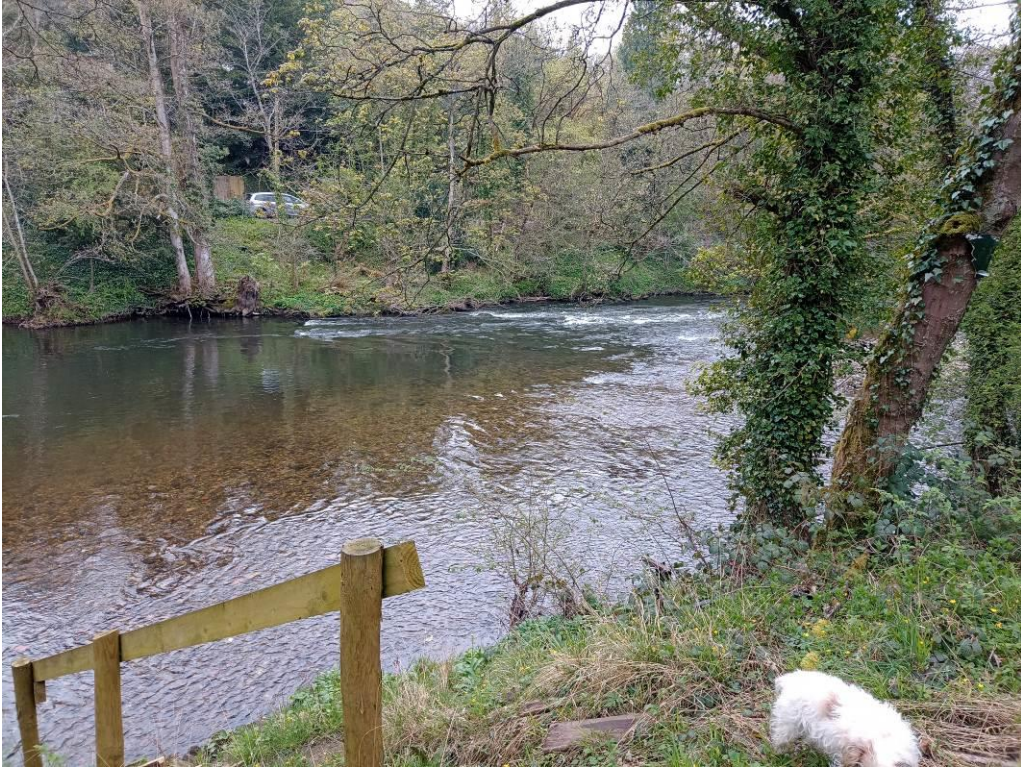
The river was walked from Cromford Bridge to the downstream limit. In general, the in-stream habitat quality within this section of the Derwent is very good. The river has a moderate to steep gradient and a good diversity of flow patterns and depths provided by the pool, riffle and glide sequence. The river bed substrate is also very varied, ranging from boulders down to sand, with a good proportion of gravel in the 5 – 100mm size range, which encompasses the spawning requirements of fish such as trout, grayling, barbel, chub and lamprey (Photo 1, Photo 2).

Photo 1 A good diversity of flow patterns and gravel substrate size

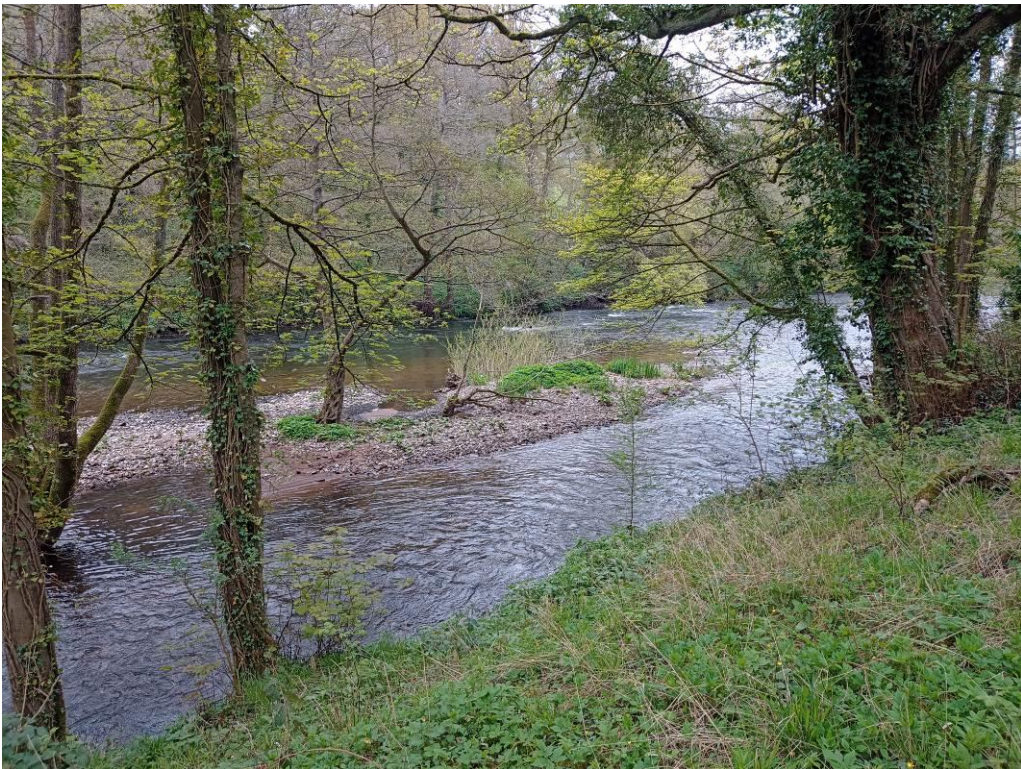
Photo 2 Excellent in-stream habitat features.

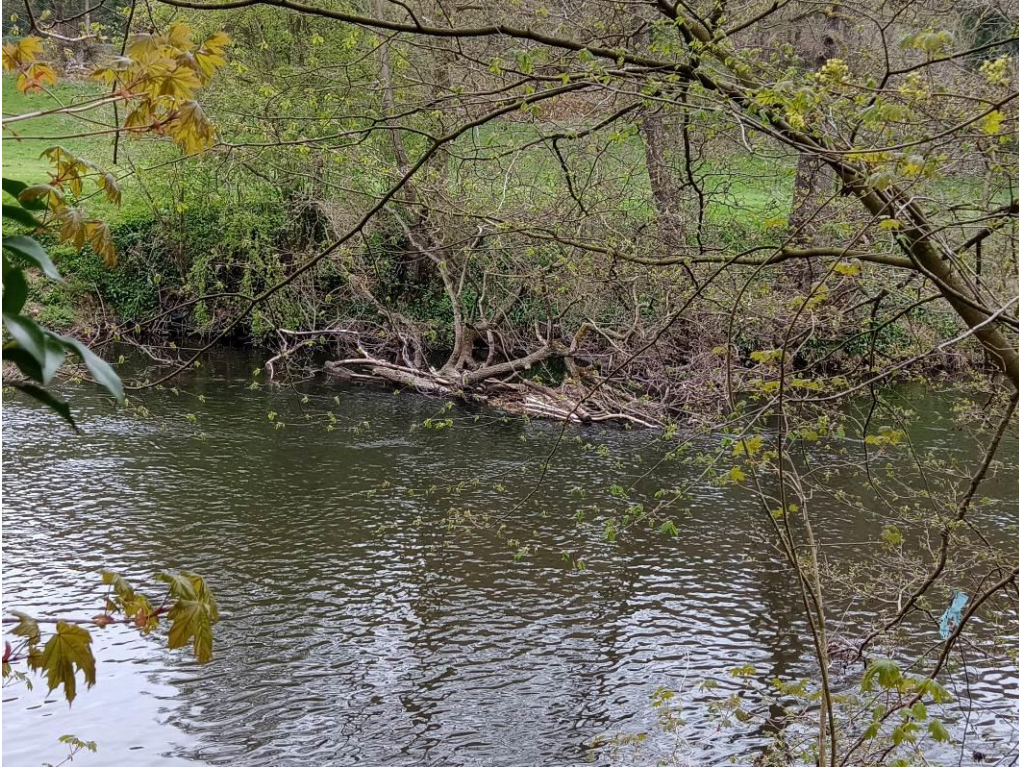
Photo 3 Naturally occurring large woody structure provides multiple benefits – fish refuge habitat, trapped leaf litter which will support invertebrate life and hence trout food, and diversity of flow patterns and gravel sorting. Leaving it in situ is the best habitat option.

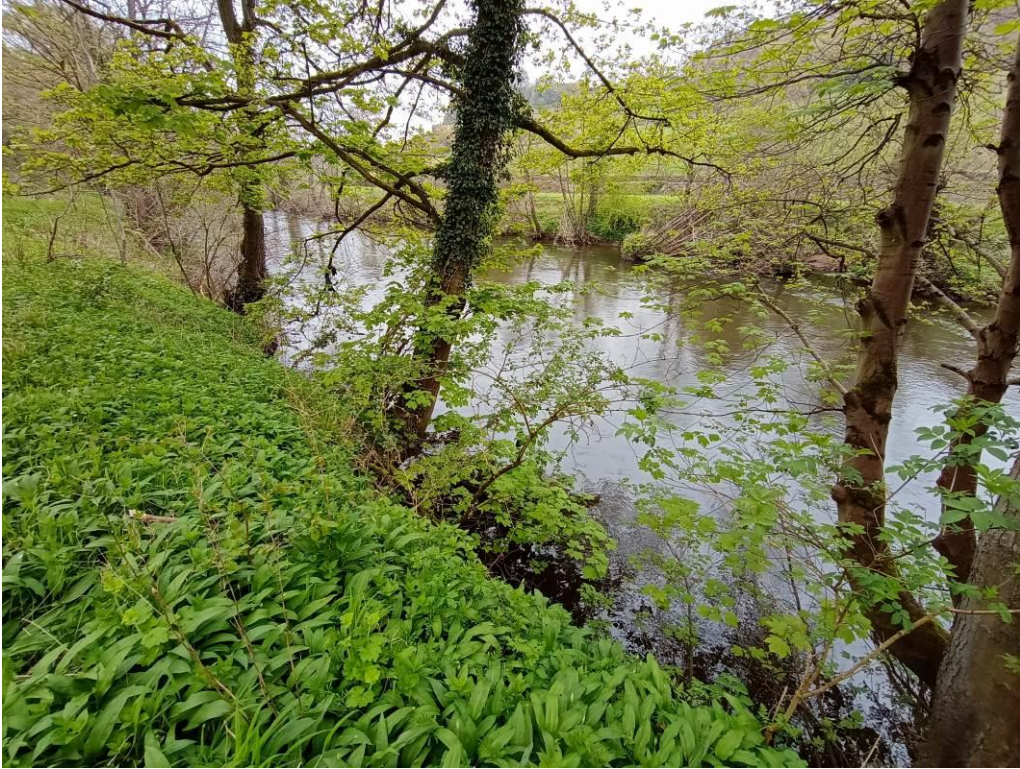
Photo 4 and Photo 5 illustrate the difference between un-grazed and grazed banks respectively. The un-grazed banks support tree succession with multiple native saplings observed. Valuable low cover over the water is provided by saplings and low branches on mature trees; this provides good lies for trout and increased angling opportunity. Healthy understory vegetation on un-grazed banks supports better invertebrate biodiversity (trout food).

Photo 4 Un-grazed banks with tree succession, good understory vegetation and good low cover over the water.

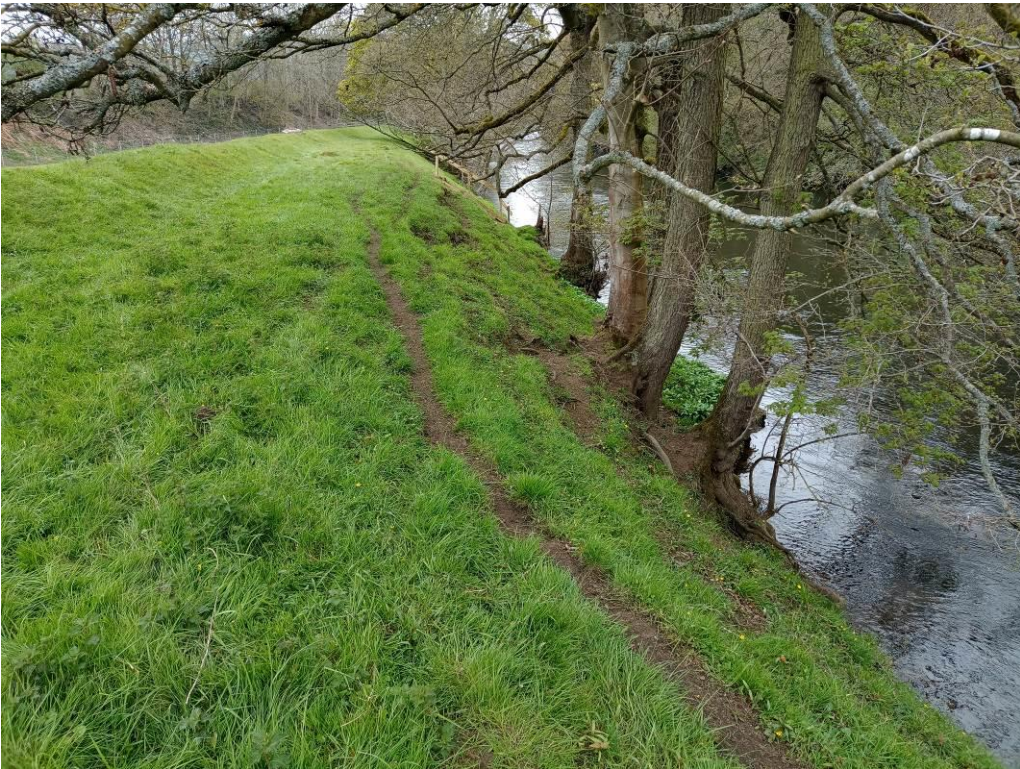
In contrast, the grazed banks have no tree succession and a short grass sward. The shallow root horizon of the latter, along with the livestock desire lines, make the banks less stable leading to an increase in the rate of loss of mature trees (Photo 6). Consequently, cover and fish-holding capacity are poorer within this section. The left bank opposite the grazed section has recently been rebuilt and protected with large stone rip-rap following a land slide that affected the road there (Photo 7), further reducing natural habitat quality within this section.

Photo 5 Grazed banks prevent tree succession, are less stable and provide little cover over the water.

- Control non-native plant species including Japanese knotweed and Himalayan balsam. The former requires specialist input (for example stem injection of herbicide by a qualified operative). The latter can be controlled by hand-pulling before it flowers (it is an annual plant).
- Exclude livestock from the grazed sections of bank. This would require close liaison with the grazier and agreement on issues such as responsibility for maintenance of fencing and provision of water for livestock.
- Retain large woody material (LWM) in the river channel for its multiple habitat benefits.
- Retain low cover over the water - avoid the removal of low branches as these create spots close to the banks where trout feel safe and choose to lie / feed. Create more low cover by 'hinging' small bankside trees (where abundant and available) into the river margins (Photo 9).

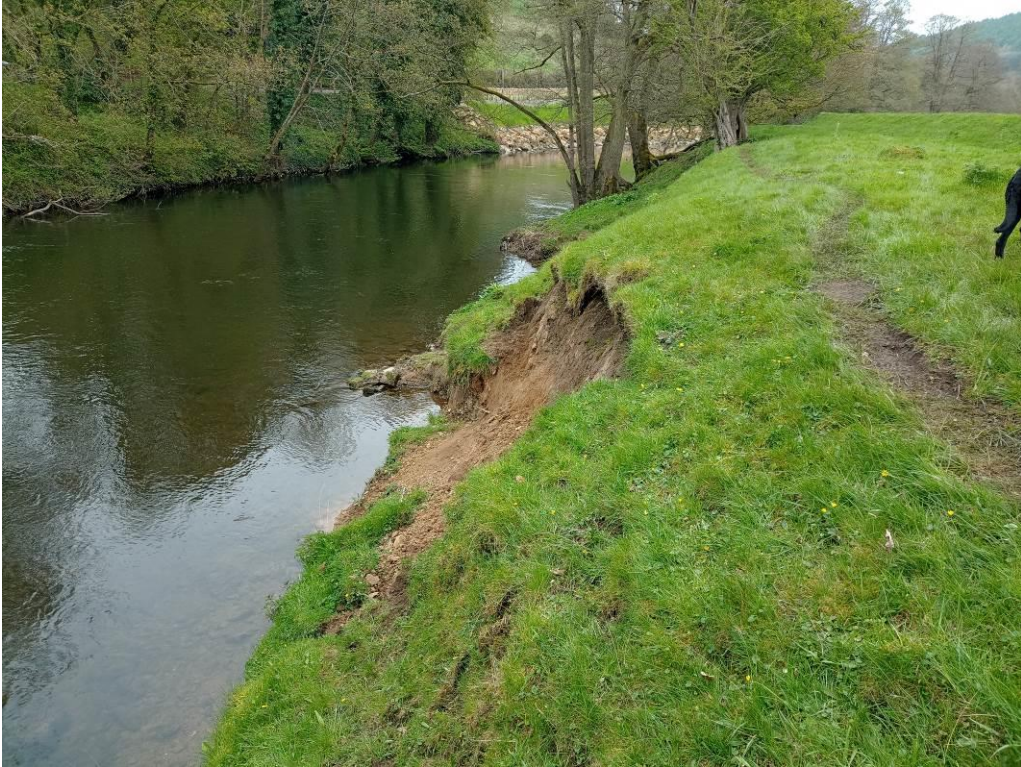
Photo 6 Possible site of a fallen tree, illustrating shallow root horizon of grass and reduced bank stability.

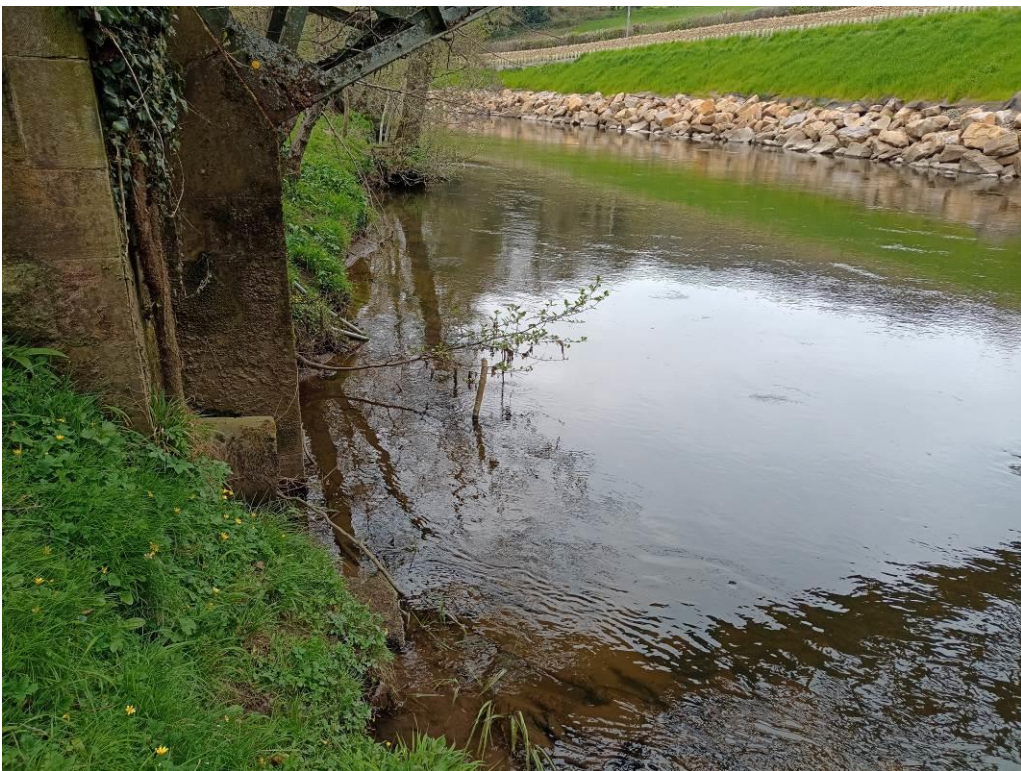
Photo 7 Hard-engineered left (far) bank and sewer storm overflow pipe (foreground).

A main sewer runs along the right bank for most of CFFC's water leading to the sewage treatment works for Matlock, where treated effluent is discharged into the river on the right bank, opposite Lea Wood (Photo 8). At one point along the sewer, CFFC reported a recent problem with a storm overflow discharging untreated sewage to the river; this was responded to quickly and fixed and is not a recurring issue (Photo 7).

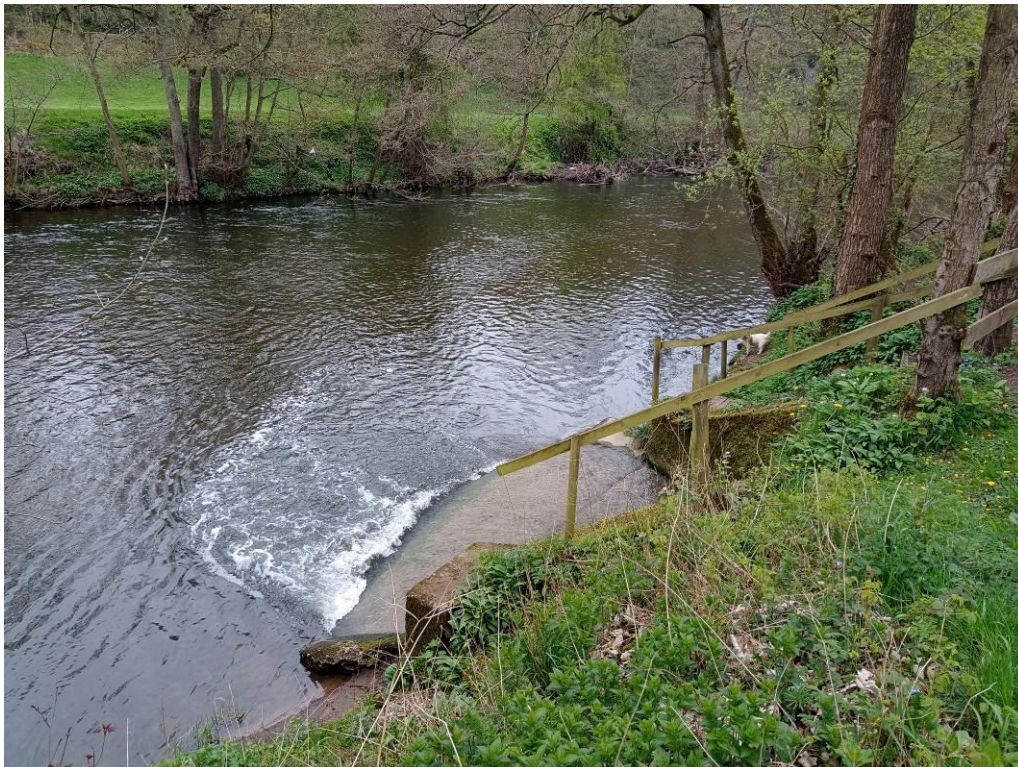
Photo 8 Treated effluent discharge from Matlock sewage treatment works.

- Continue with the Riverfly Partnership Anglers' Monitoring Initiative and other water quality monitoring initiatives.

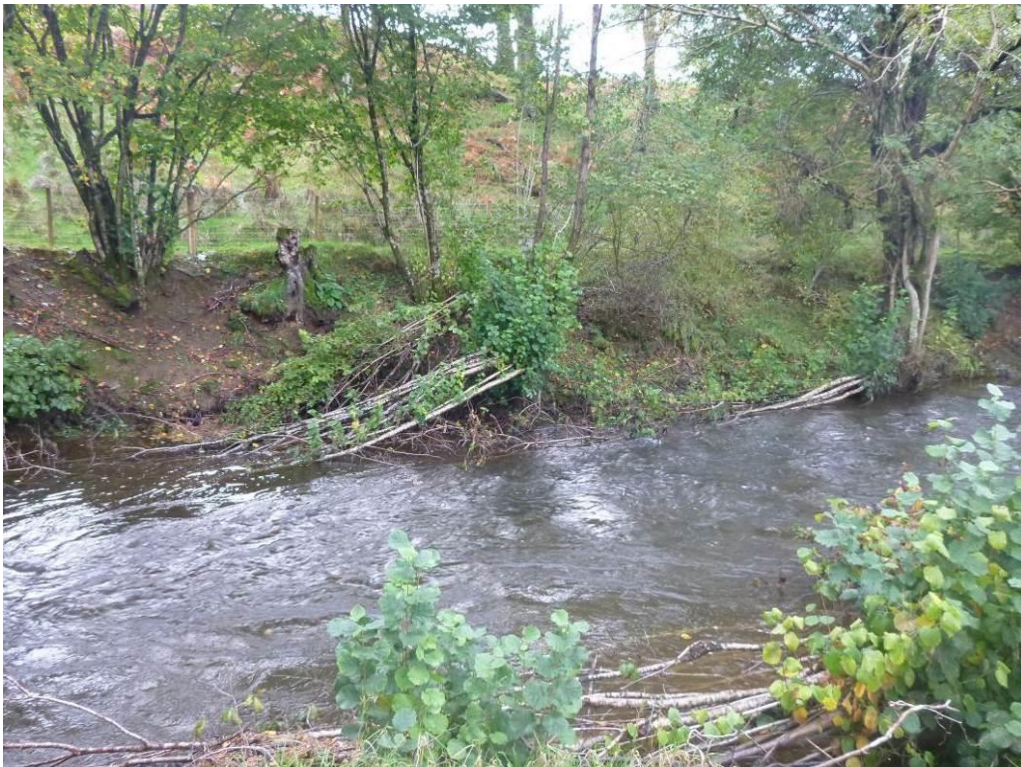
Photo 9 Laying small trees/coppice re-growth to provide low cover in/over the river.
